Technical Report CHL-99-3
March 1999

Monitoring Completed Navigation Projects Program

Inspections of Previously Monitored Coastal Structures

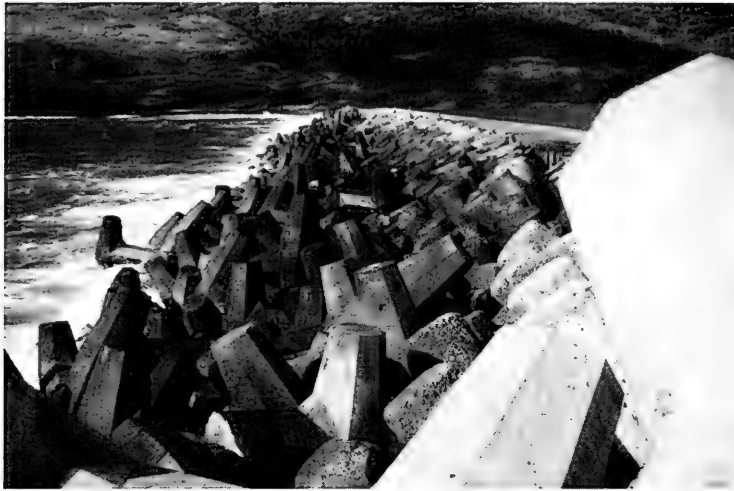
The breakwater (Figure 3) was inspected on 22 July 1998. The inspection indicated that most of the armor units were in similar positions as recorded during the 1995 survey based on detailed photogrammetric maps of the structure. Numerous broken armor units were observed, but were validated as those documented in the 1995 survey. Fragments of some of the broken armor units were still in the same locations as observed in 1995. It was noted that the older 16,150-kg (17.8-ton) tribars are showing major surface spalling of concrete (Figure 4), but this is not felt to put the structure in any danger of instability. Overall the structure is in good condition.

Figure 3. Sea side of Nawiliwili Harbor breakwater

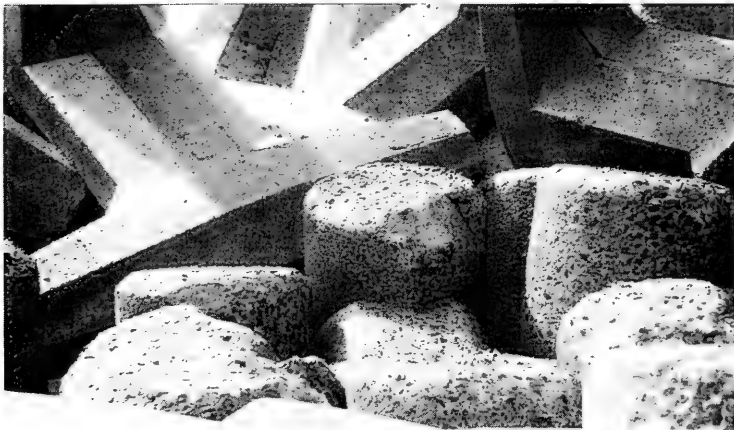
Figure 4. Surface spalling of tribars on Nawiliwili breakwater

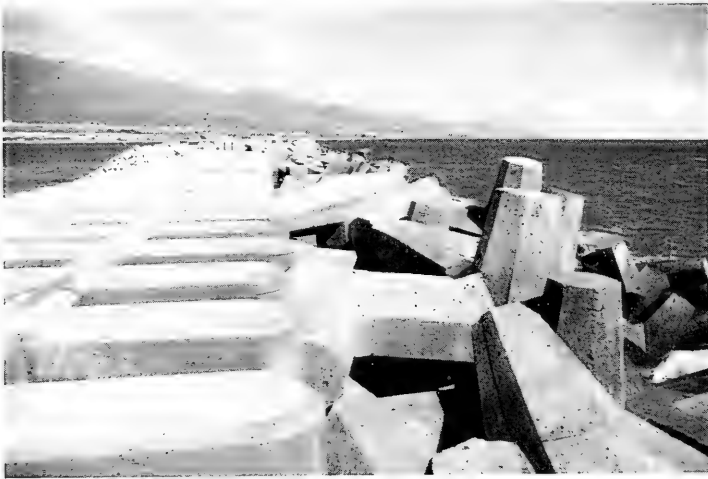
The Kahului Harbor breakwaters were inspected on 21 July 1998. The inspection, as close as could be observed visually, indicated that most of the armor unit positions were similar to those obtained during the 1993 survey. Views of the structures are shown in Figures 6 and 7. On the east breakwater it appeared that two 31,750-kg (35-ton) tribars had flipped and slid downslope slightly on the sea side of the structure at approximately sta 10+50. Additional breakage of some of the 5,445-kg (6-ton) dolosse

Figure 6. Kahului east breakwater

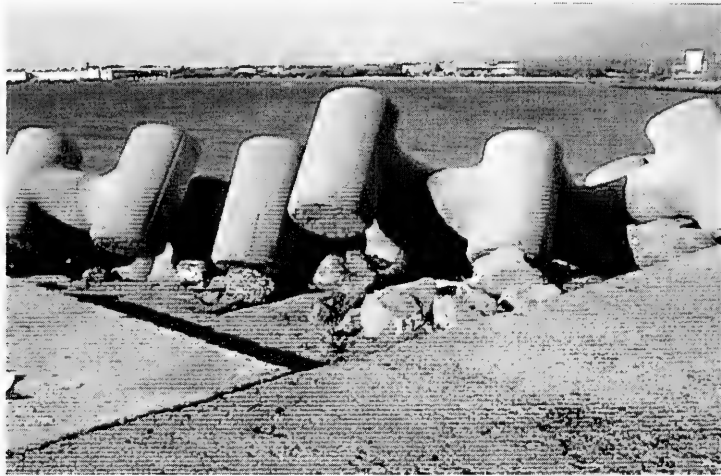
(sta 6+20 thru 7+10) on the sea side of the structure was noted since the 1993 survey. Eleven broken units were observed in this area as opposed to nine documented broken units during the 1993 survey. During the west breakwater inspection, a concentration of broken 27,215-kg (30-ton) dolosse was noted on the sea side of the head. Twelve broken/cracked units were observed versus eleven documented during the 1993 survey. Also, some of the 5,900-kg (6.5-ton) tribars on the harbor side of the breakwater close to its head appeared to have lifted and tilted downslope

(possibly due to overtopping waves, Figure 8). No voids and breaches were noted in the breakwaters, and the overall condition of both structures was considered good.

Figure 8. Tribars that appear to have tilted downslope (Kahului west breakwater)

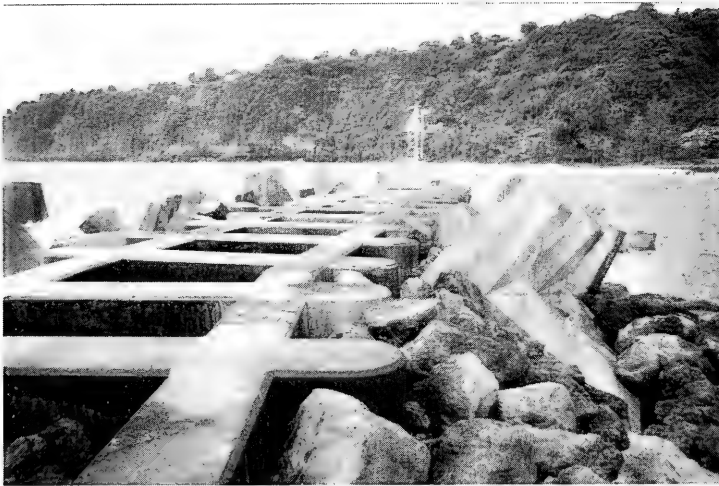
The Laupahoehoe breakwater (Figure 10) was inspected 22 July 1998. The inspection indicated that the armor units were in the same positions

Figure 10. Laupahoehoe breakwater

as documented in the 1993 survey. No broken armor units were observed, and the structure is considered to be in excellent condition.

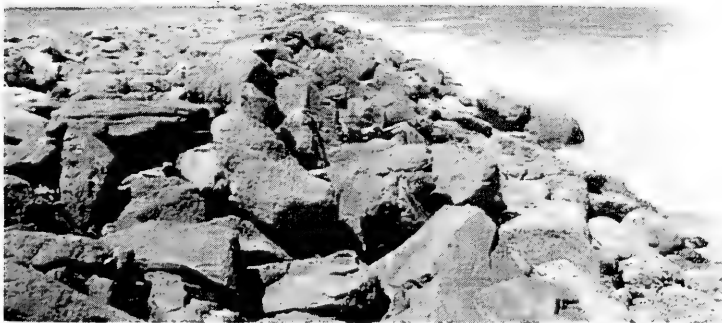
An inspection of the north jetty (Figure 12) on 24 June 1997 revealed that the head of the structure no longer existed. Comparisons to photogrammetric data obtained in May 1993 indicated that approximately 50 m (165 ft) of the north jetty head was no longer above water, and stone had apparently been removed to below the water level by wave action. When the notch area was not visible, measurements from known locations on the structure were made to confirm this finding. Remnants of some of the jetty could be seen seaward of the structure in wave troughs as they passed. Above-water stone around the head was not uniform (Figure 13). Other observations of the structure revealed some low areas in the crest and some voids on the sea side of the jetty. At a location approximately 305 m (1,000 ft) shoreward of the jetty head (the head location of 24 June 1997), low areas in the crest existed over about a 30.5-m (100-ft) span.

Figure 12. Yaquina Bay north jetty

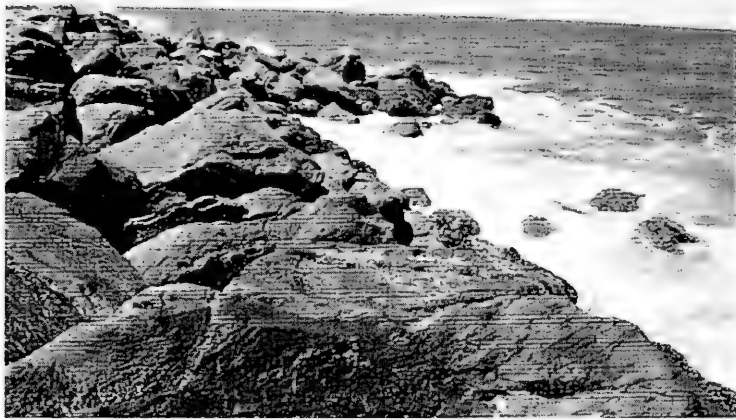
Figure 13. Head of Yaquina Bay north jetty on 24 June 1997

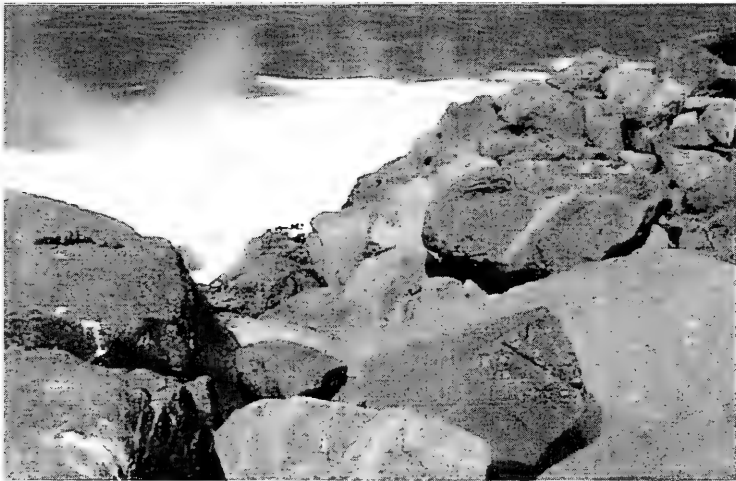
Another low area was observed on the crest about 520 m (1,700 ft) shoreward of the jetty head, and a void on the sea side of the jetty was observed approximately 580 m (1,900 ft) from the jetty head (Figure 14). An even larger void on the sea side of the structure was observed about 650 m (2,125 ft) shoreward of the jetty head as shown in Figure 15.

Figure 14. Void on seaward side of Yaquina north jetty observed approximately 580 m (1,900 ft) from head

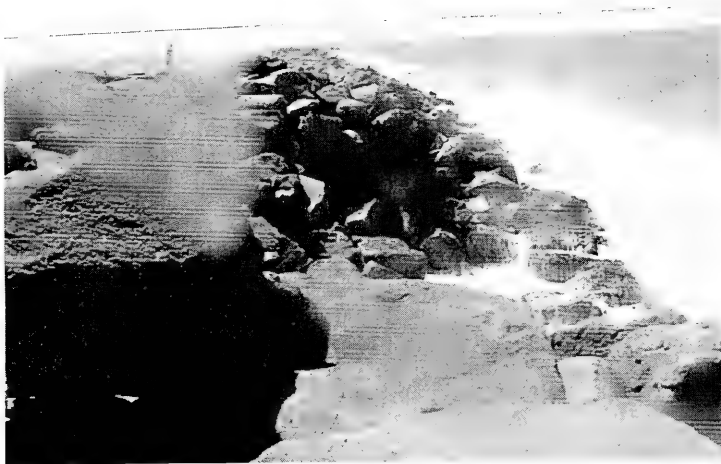
Figure 15. Void on seaward side of Yaquina north jetty observed about 650 m (2,125 ft) from head

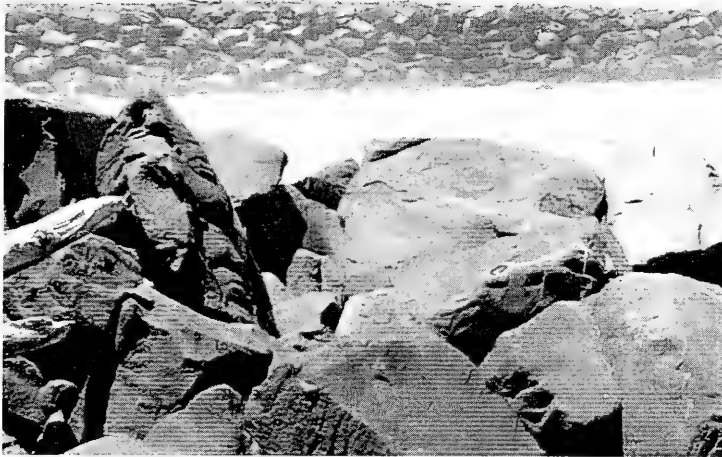
An inspection of the jetty system on 26 June 1997 revealed that some repairs were needed. On the north jetty head, a void was observed on the channel side of the structure. The area was steep, and it appeared that stone had been pulled downslope by wave action as remnants could be seen seaward of the area. About 20 m (65 ft) shoreward of the jetty head, a low area in the center of the crest existed; and approximately 27.5 m (90 ft) from the head a void existed on the channel side of the structure. In several areas along the jetty extension, it appeared that the center portion of the crest had subsided and the elevation was irregular. The stone along the slopes, however, appeared to be up to required elevation. At a point about half the length of the jetty spur, it appeared a stone had been uplifted leaving a small void (Figure 17). With the exception of the jetty head, the slopes on the north jetty extension and jetty spur were in good condition. Inspection of the south jetty extension indicated a similar situation at the jetty head on the sea side of the structure. The slope was very steep, and it appeared that stone had been pulled downslope by wave action (Figure 18). The head of the south jetty spur also was damaged on its shoreward side as evidenced by a lack of stone above the water surface (Figure 19). In addition, immediately shoreward of the jetty spur head, a void existed on the shoreward side of the spur (Figure 20). The side

Figure 17. Displaced stone on north jetty spur at Siuslaw

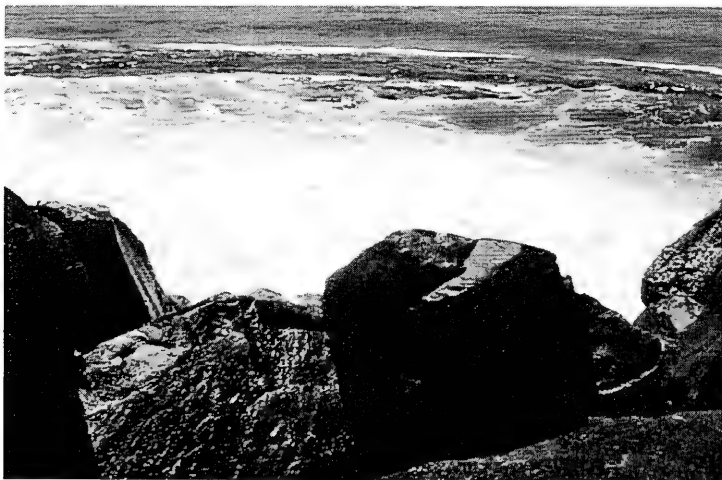
Figure 18. South jetty head at Siuslaw

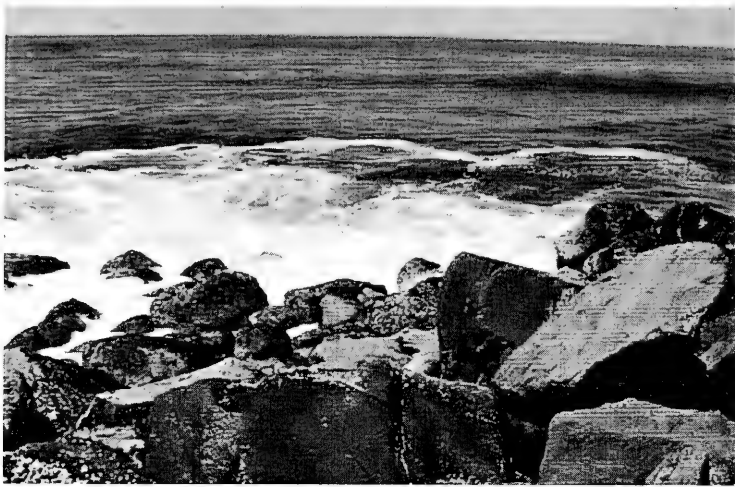
Figure 19. Head of Siuslaw River south jetty spur

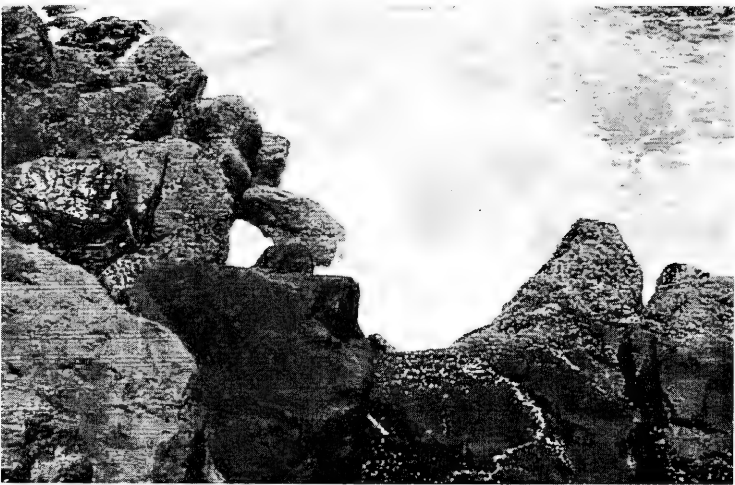
Figure 20. Void in south jetty spur at Siuslaw

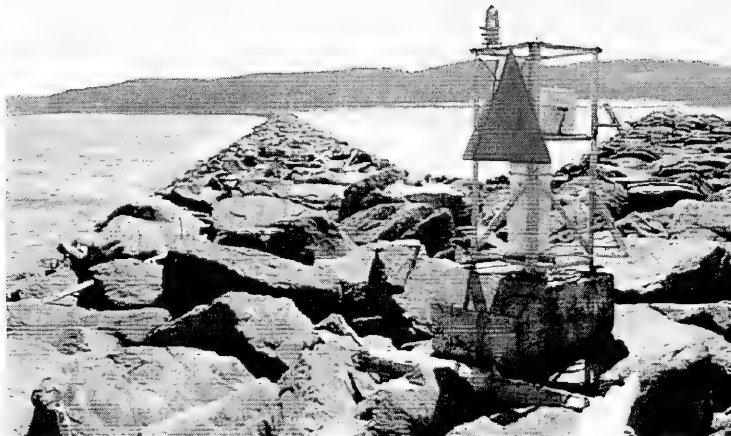
The training jetty and south jetty were inspected on 25 June 1997. Inspection of the training jetty revealed that the 1980 extension was in very good condition (Figure 22). Its cross section appeared to be uniform along its length, and very few of the armor stones had cracked. The shoreward portion of the structure (1951 construction) had some areas that appeared to be damaged on the shore side. This was prevalent immediately landward of the shoreline where stone from the back side of the jetty was scattered (Figure 23). The channel-side face of this portion of the training jetty was in good condition. Inspection of the south jetty revealed a

Figure 22. View of Umpqua River training jetty (left structure) looking shoreward

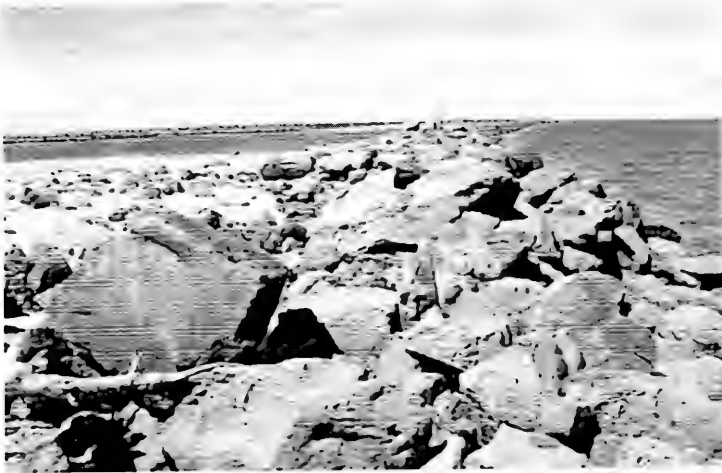
Figure 23. Scattered armor stone on shore side of Umpqua training jetty

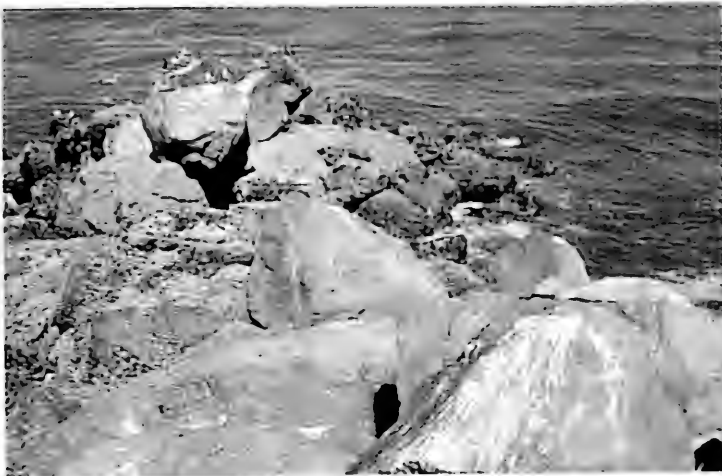
breach at its head. The breach did not extend below the water level, but extended through the jetty (Figure 24). In addition, just shoreward of the breach, a large void existed on the sea side of the structure (Figure 25). The trunk of the south jetty was in good condition.

Figure 24. Breach at head of Umpqua River south jetty

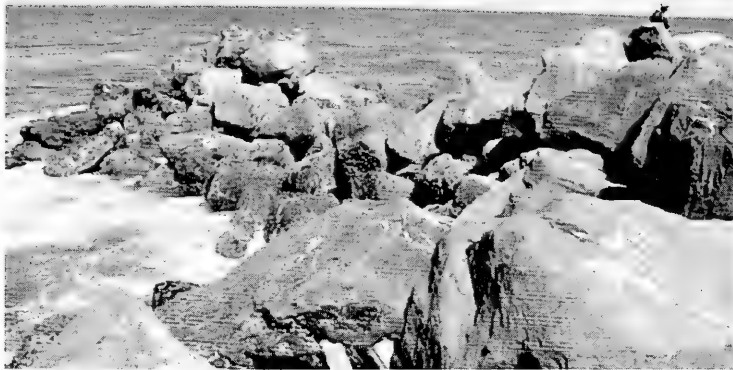
Figure 25. Breach and void at head of south jetty at Umpqua River

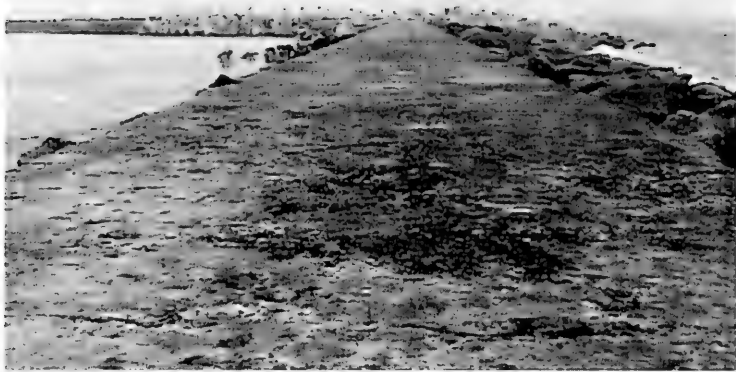
The Crescent City Harbor breakwater (Figure 27) was inspected on 15 September 1998. The inspection indicated that most of the armor unit positions were similar to those shown in the 1993 photography as close as could be observed visually. It appeared that only a couple of the 38,100-kg (42-ton) units had changed positions slightly along the waterline at the outer portion of the main stem. Figure 28 shows some of these units at the head of the main stem of the breakwater. Numerous broken armor units were observed, but were validated as being broken in the 1993 survey. Overall the structure is in good condition.

Figure 27. Crescent City Harbor breakwater

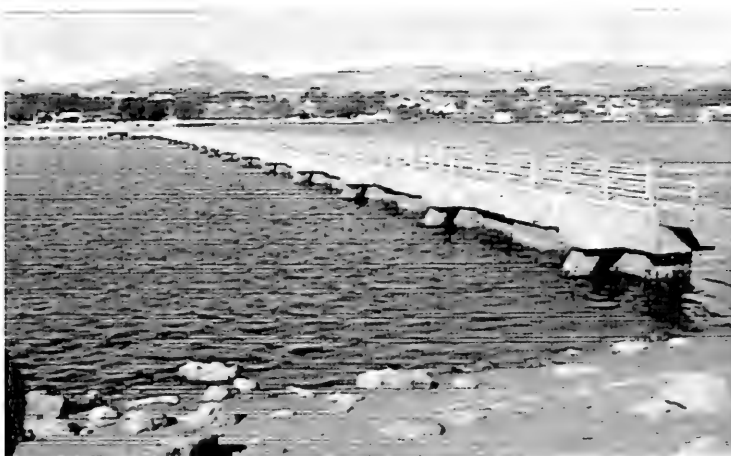
The Spud Point Marina breakwater (Figure 30) was inspected on 16 September 1998. The assessment revealed no evidence of misalignment, movement, spalling, or subsidence of the structure. The hairline cracks across the top of the breakwater cap noted in the earlier surveys did not appear to have widened (Figure 31). Additional hairline cracks were observed, particularly on the vertical sides of the cap. Some of these cracks

Figure 30. View of marina side of shoreward leg of Spud Point breakwater

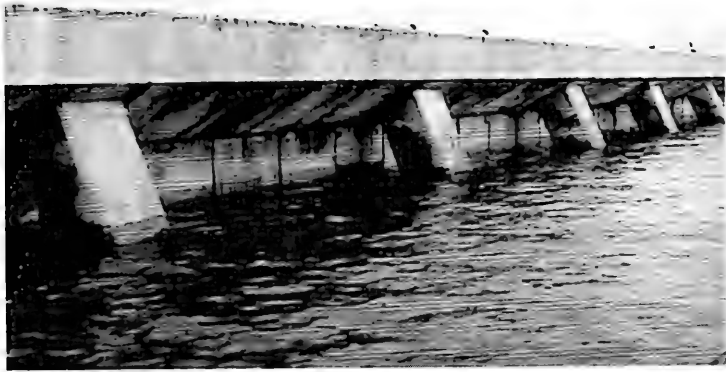
The Fisherman's Wharf breakwaters were inspected on 17 September 1998. Visual assessment of the structures was conducted by running a boat along the sides of the breakwaters and walking the main breakwater cap. A portion of the main detached breakwater is shown in Figure 34. The inspection revealed no deterioration or apparent settlement of the breakwaters. Numerous areas along the concrete piles between the main breakwater cap and the waterline were spalled (Figure 35). These areas are not threatening the structural integrity or function of the structure. The overall condition of the breakwaters was very good to excellent.

Figure 34. Portion of detached breakwater at Fisherman's Wharf Harbor

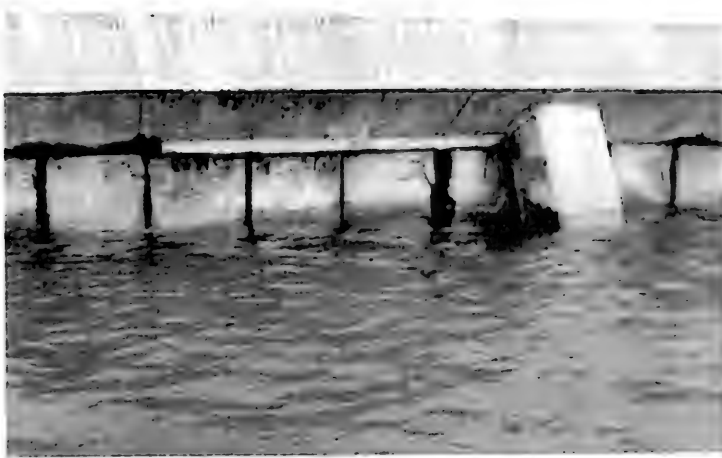
Figure 35. Spalling of concrete piles between the breakwater cap and the water surface at Fisherman's Wharf Harbor

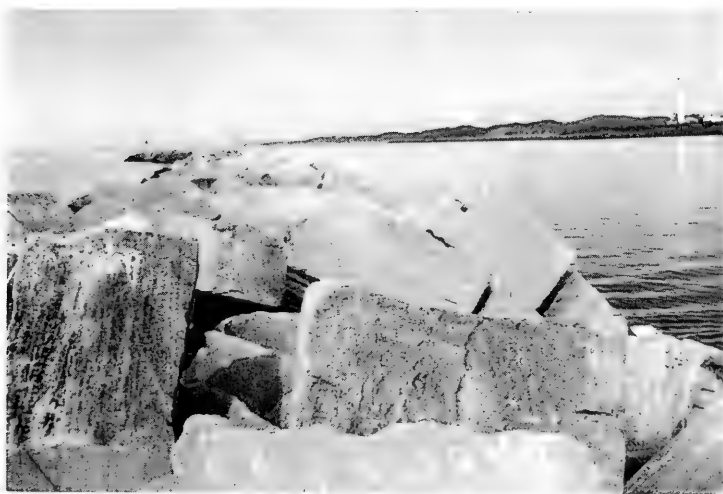
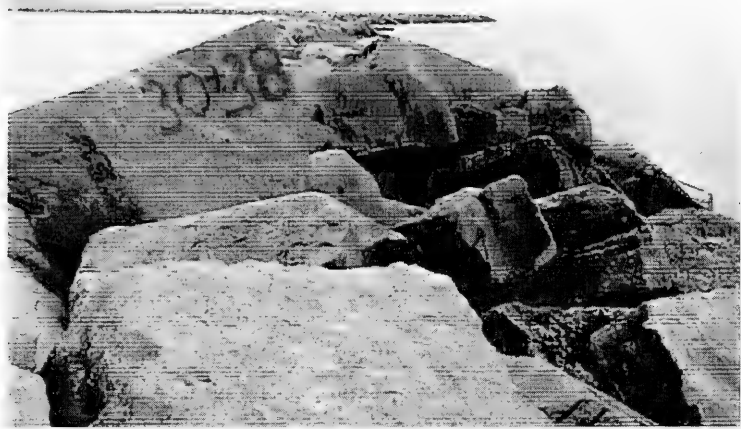
The Burns Harbor north breakwater (Figures 37 and 38) was inspected on 17 June 1998. The elevation of the breakwater was compared to topography data obtained previously during the photogrammetric analysis. Sections of the structure in which it appeared that low areas existed since the last inspection are shown in the following tabulation.

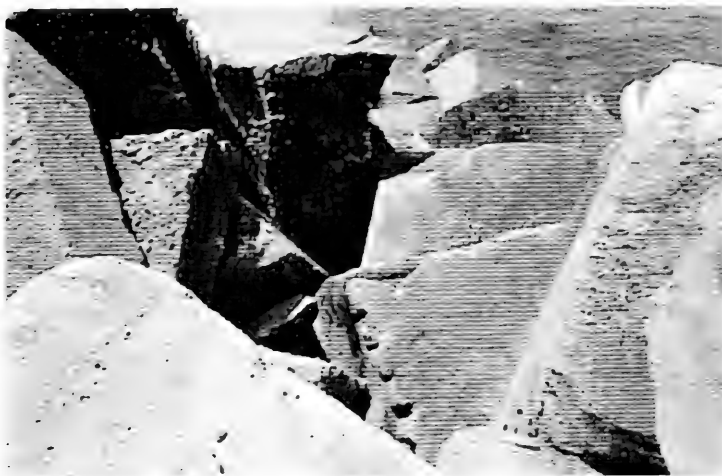
The inspection also indicated several voids in the breakwater. Figures 39 and 40 depict typical voids in the Burns Harbor structure. It appeared that continued deterioration of the breakwater had occurred since the last inspection.

Figure 39. Void on lakeward crest of Burns Harbor breakwater

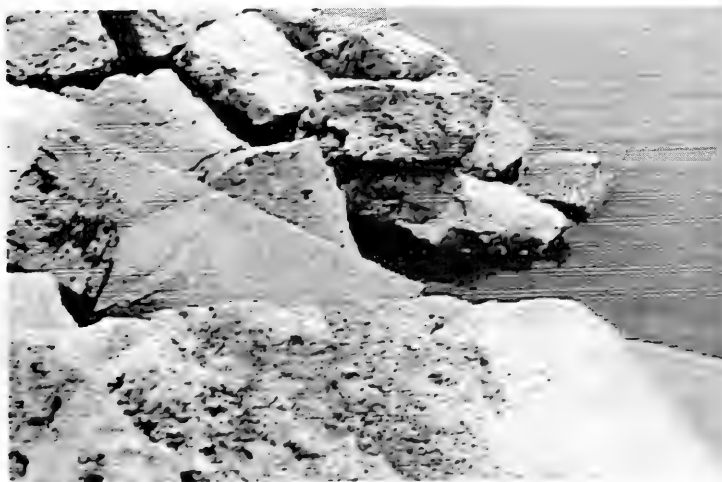
Figure 40. Typical void in harbor side of Burns Harbor breakwater

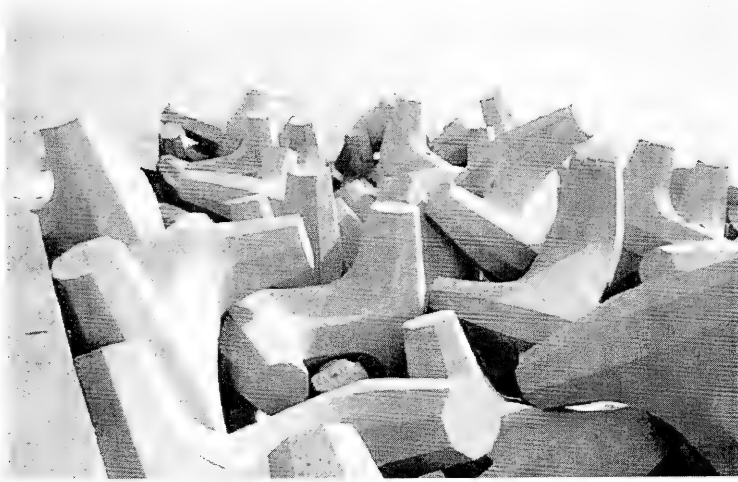
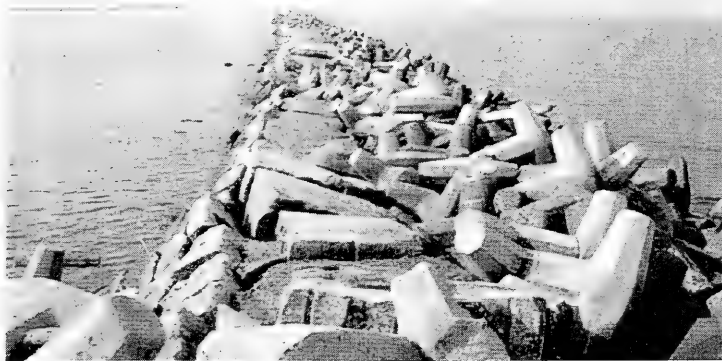
The Cleveland Harbor east breakwater (Figures 42 and 43) was inspected on 7 October 1997. The inspection revealed that the structure has changed little since the 1993 survey. Comparison of armor unit positions

with detailed, rectified aerial photography, in general, revealed that most of the armor units were in the same position as in 1993. Even fragments of broken dolosse were in the same positions based on the aerial photographs. Apparent armor unit movement was observed at only one location along the structure. At sta 262+55 one dolos had moved downslope slightly and an adjacent dolos had flipped upslope. It was also noted that some new 3,628-kg (4-ton) dolosse had been placed between sta 253+50 and 254+00 since 1993. The structure is in fair to good condition and appears to be functioning well.

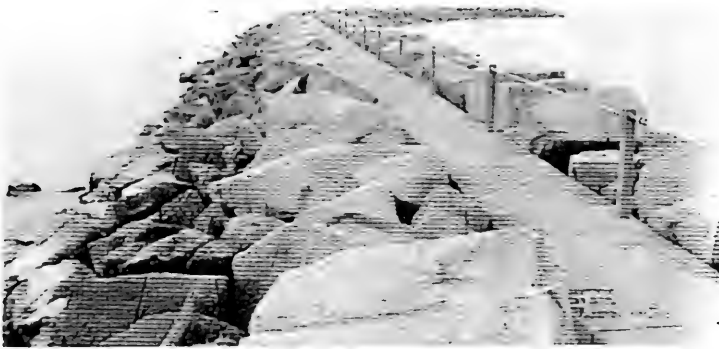
An inspection of the Cattaraugus Creek Harbor south breakwater (Figure 45) on 8 October 1997 revealed voids in the armor stone layer at two locations on the lake side of the breakwater along the curved portion (sta 15+00 and sta 16+50). The void at sta 16+50 is shown in Figure 46. An additional void was observed on the head of the structure (Figure 47), which resulted in a steep slope. During the inspection several broken stones were observed sporadically along the structures; however, overall the structure appears to be in good condition. The north breakwater was inaccessible and not inspected. It is protected by the curved south structure.

Figure 45. Cattaraugus Creek south breakwater looking lakeward

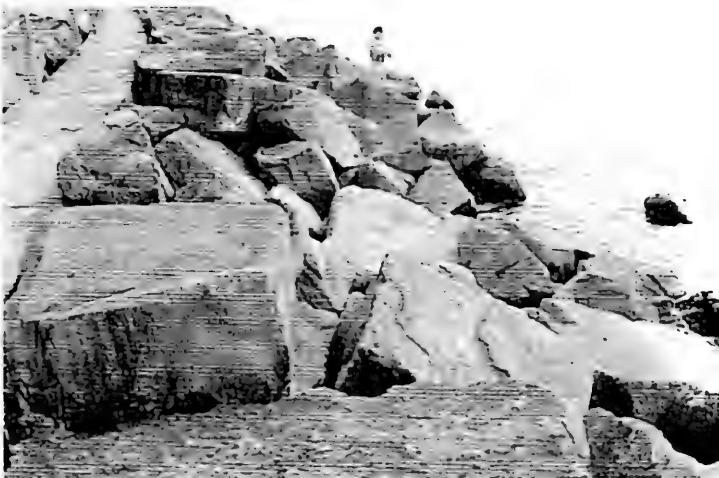
Figure 46. Void along trunk (sta 16+50) of Cattaraugus Creek south breakwater

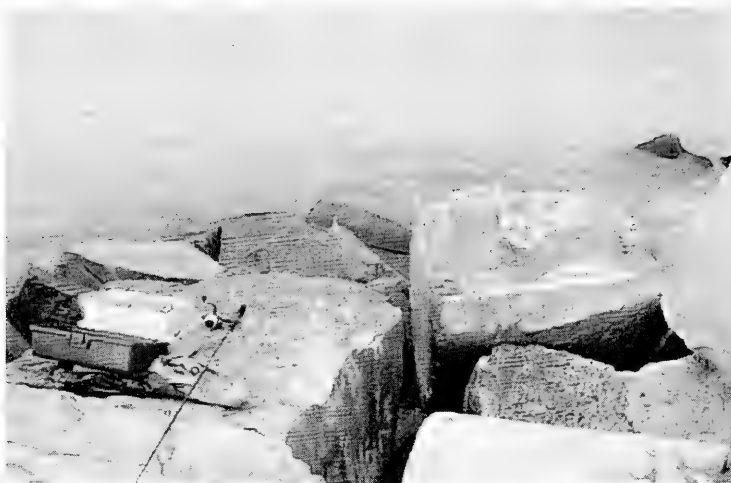
Figure 47. Void and steep slope at head of Cattaraugus Creek south breakwater

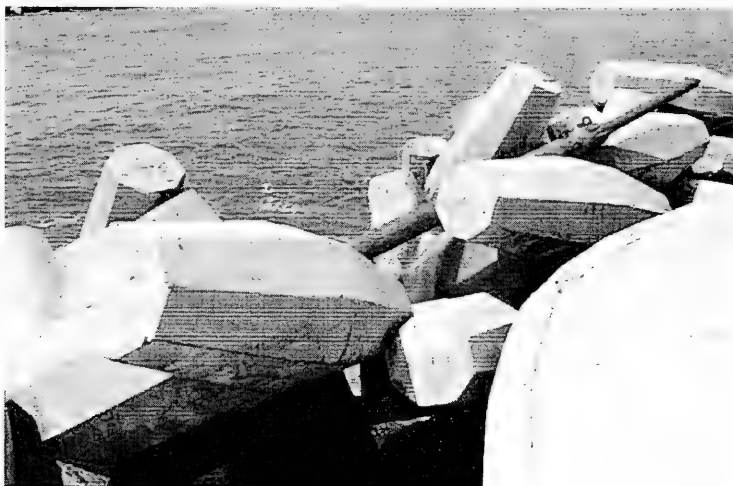
elevation. Seven of these units were adjacent to the void area (Figure 50) on the south side of the jetty head, which had been identified in the 1994 survey. The void area also appeared slightly larger than in 1994. Two armor units on the north side of the structure and four on the seaward tip of

Figure 50. Void area on south side of Manasquan Inlet north jetty head

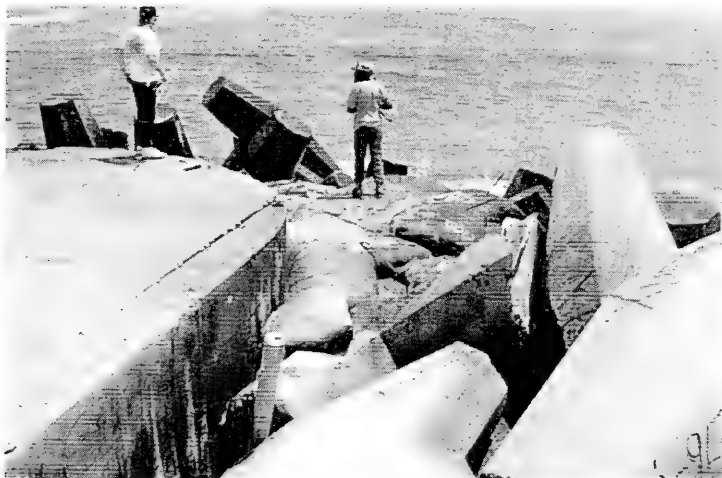
Figure 51. Emergency repair work (grout-filled bags) at head of Manasquan Inlet south jetty

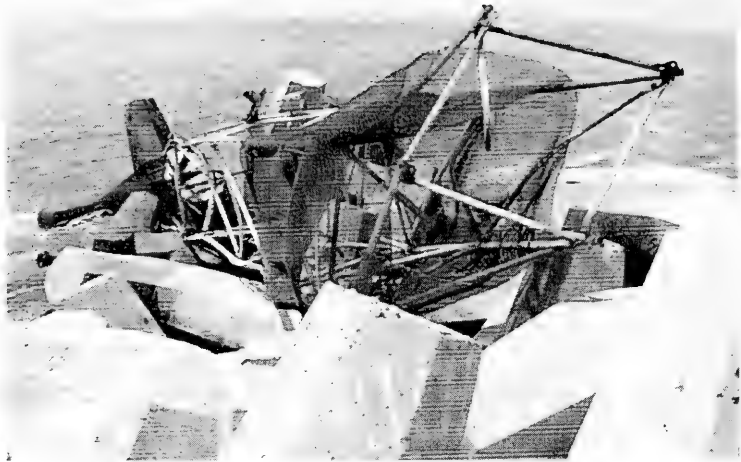
Figure 52. Lighthouse base washed into Manasquan Inlet south jetty as a result of 1995 storm

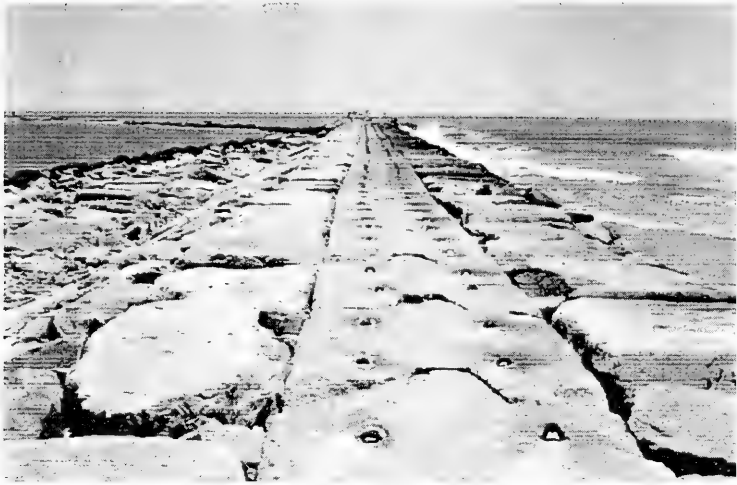
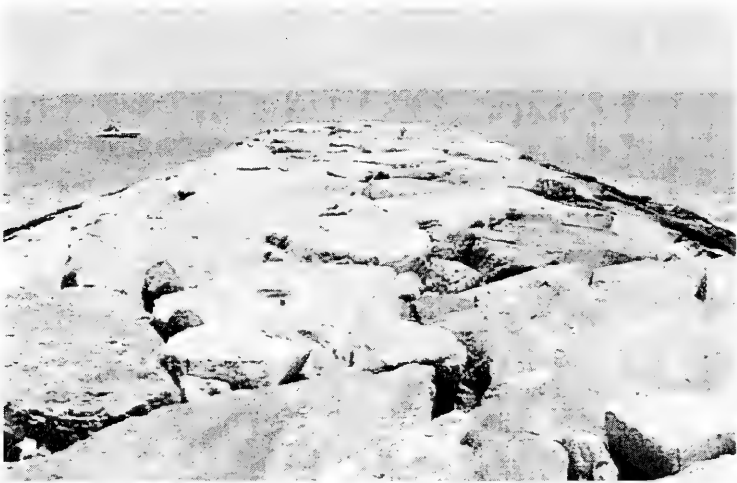
The rehabilitated south jetty and headland breakwaters at Ocean City Inlet were inspected on 11 June 1997. The rehabilitated south structure is shown in Figures 54 and 55, and the headland structures are shown in Figure 56. The inspection revealed these structures to be in excellent condition. No voids were noted, no armor stones were broken, and the cross sections of the structures appeared to be as built. It was noted that the seaward section of the old south jetty (that extending beyond sta 13+00) was in disarray. Armor stones were scattered, the crest height was inconsistent, and no definite cross section was apparent (Figure 57).

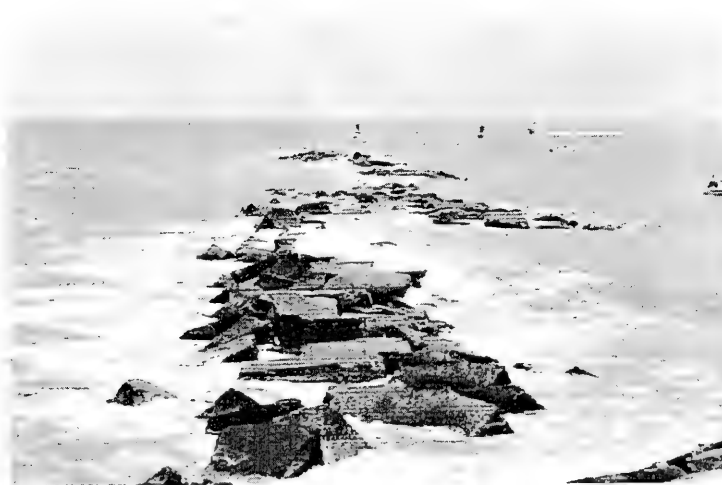
Figure 57. Seaward section of existing south jetty at Ocean City Inlet (beyond sta 13+00)
